Ash Pits and Incinerator IHSS Briefing Summary

Rev 0 (5/05)

SW-1

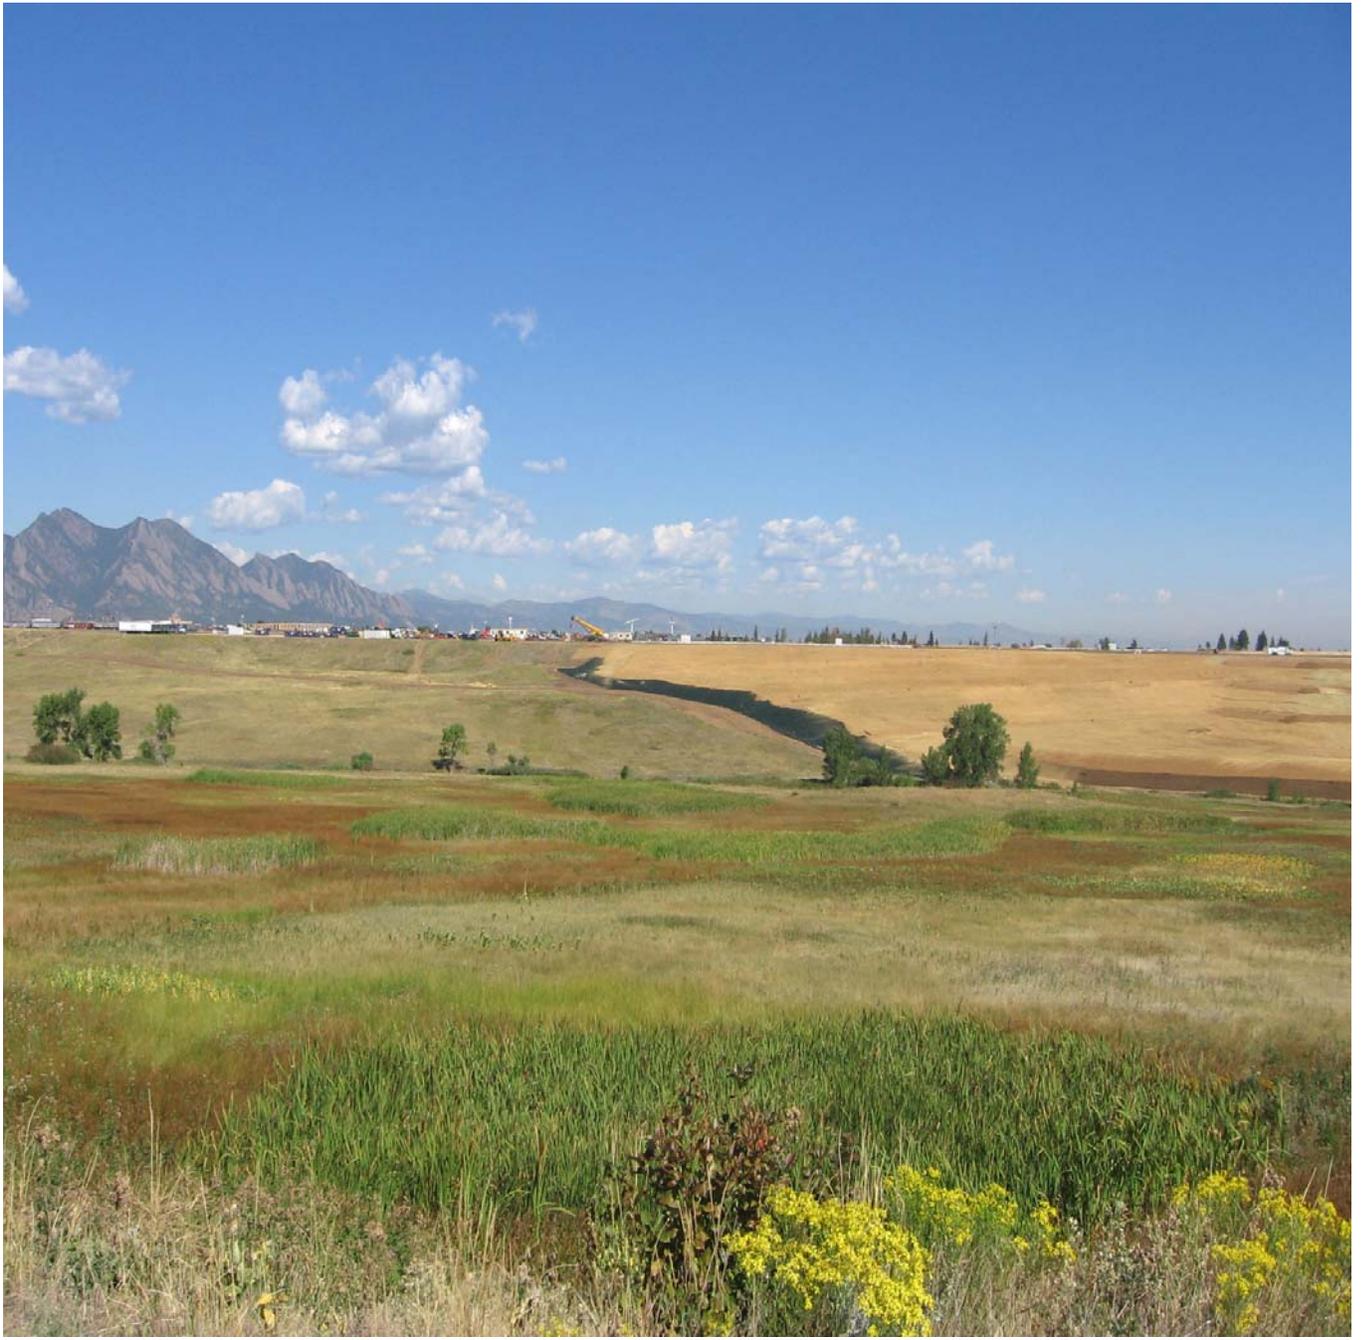
(Note: Figure 1, page 4, September 2005, is a photo showing the ash pits/incinerator area located just to the west of the remediated original landfill)

Figure 1. View looking north across Woman Creek Drainage September 2005. The Ash Pits and Incinerator were located just to the west (left in photo) of the remediated Original Landfill site.
