Solar Evaporation Ponds IHSS Briefing Summary

Solar Ponds

IHSS 101, PAC 000-101

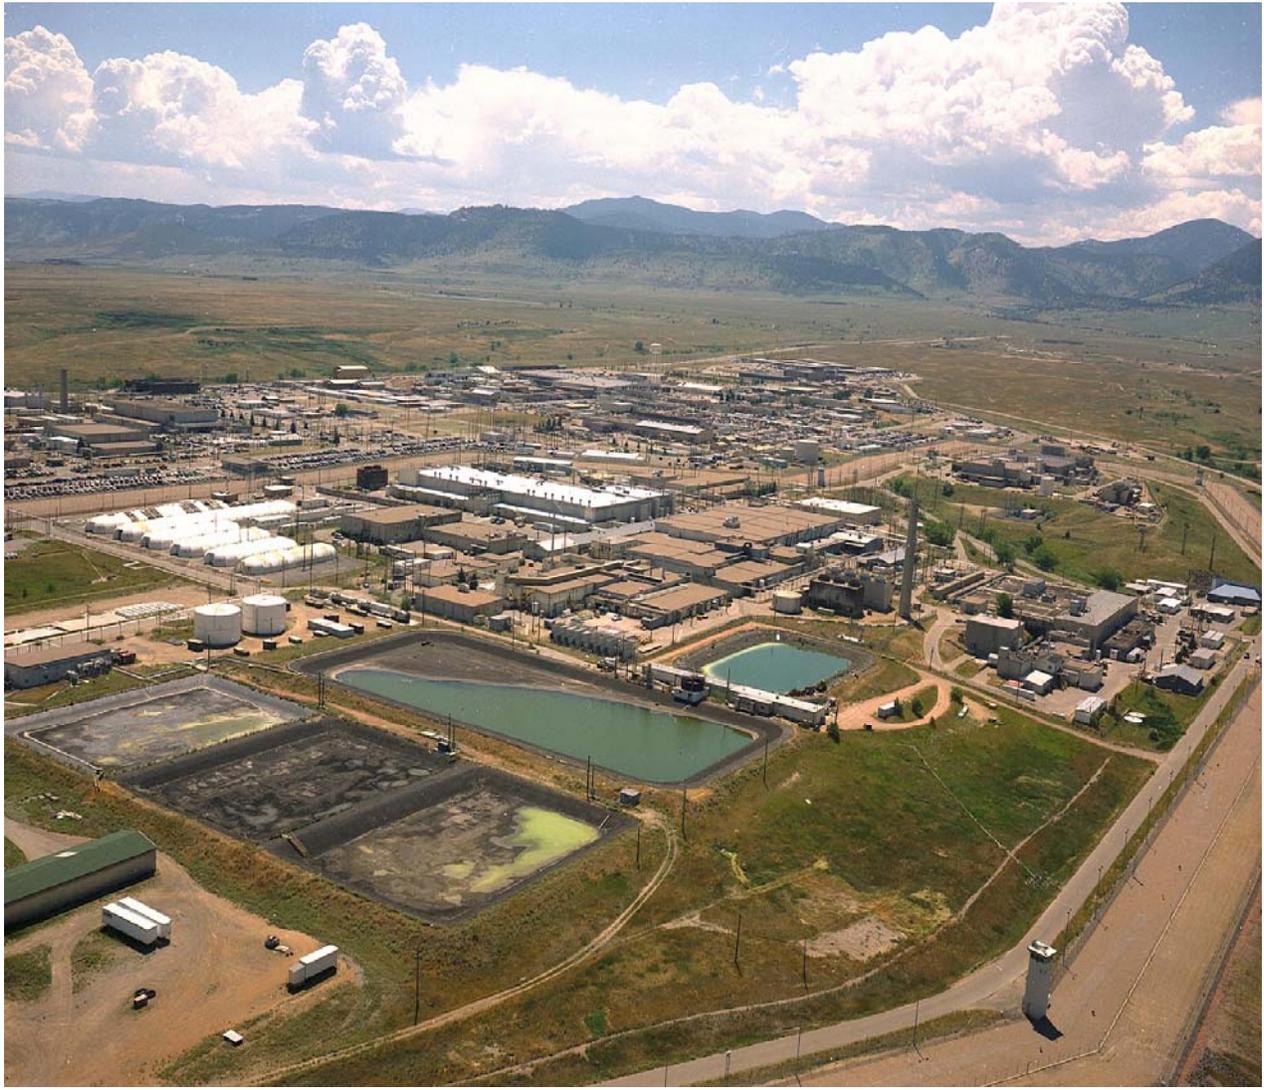
Figure 1. Aerial view looking southwest of central Industrial Area (CIRCA 1995) with Solar Evaporation Ponds in foreground

The initial SEPs were built during the 1950s when liquid (aqueous) waste processing in Building 774 was not able to keep up with increasing waste treatment demands (see Figure 1, page 4, 1995 photo of SEPs). When the Site was designed, there was not enough attention paid to waste processing. Hence, when production output increased, the amount of liquid wastes increased which strained the treatment capacity of Building 774. These wastes were transferred from throughout the Site via the Original Process Waste Lines (IHSS 121 Briefing Summary) to Building 774 for processing.

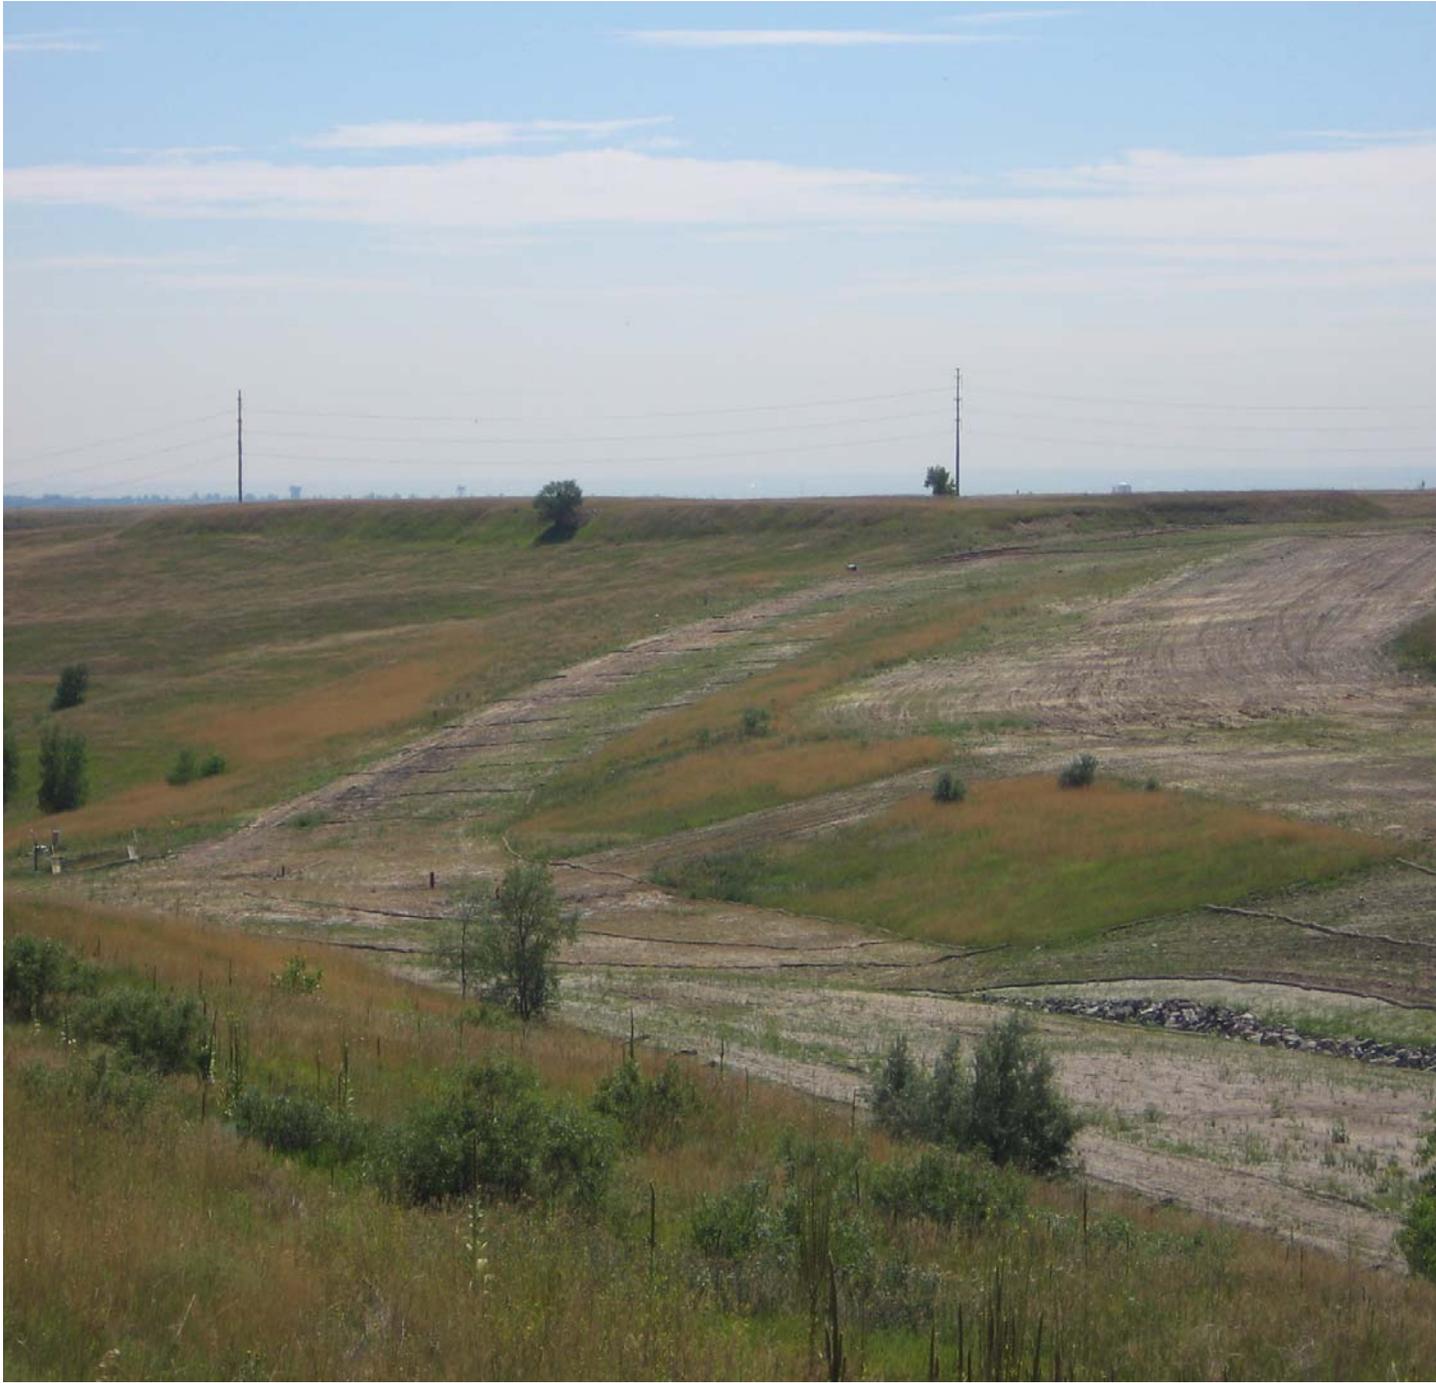
Figure 2. SEP passive groundwater treatment system located at the left edge of photo to treat nitrate and uranium contaminated groundwater before it migrates to North Walnut Creek.

Long-term stewardship controls are critical for the SEP. One critical component of this IHSS is the performance of the passive groundwater treatment system and any other remedial systems employed downgradient of the passive groundwater treatment system (see Figure 2, page 5). Of equal importance is the groundwater and surface water monitoring network that will be established for the post-closure Site. These networks are currently being developed by the Integrated Monitoring Plan (IMP) Working Group. Members of the IMP include the Site, EPA, CDPHE, and local stakeholders. A robust monitoring network surrounding the SEP and SEP plume is needed to effectively monitor the status of the remediation. This document will be updated when final monitoring locations are selected. However, if those initial monitoring locations don't prove adequate in the future, the post-closure IMP calls for additional monitoring if required.
